Examples of water pump failure

4 Read before water pump installation

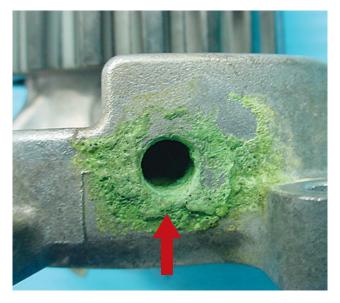
Non-conforming sample

Dirt, particles, or sludge, etc. in the coolant get caught in the sliding surface of the mechanical seal, which wears the sliding surface down, reducing the effectiveness of the seal and causing water leakage.

The traces of leakage are large, the marks are constantly wet or dripping.

Thoroughly flush the cooling system 2-3 times to remove the stains and rust with the engine running and the original water pump still in place.

Replace the LLC on a regular basis to the amount and density specified by the manufacturer.

Usage of liquid gasket Do no use the liquid gasket if the gaskets are supplied with the pump. When using liquid gasket, apply evenly so that any excess does not stick out into the water chamber.
